Helicopter Safety Performance

2013-2018

HeliOffshore
Safety Through Collaboration

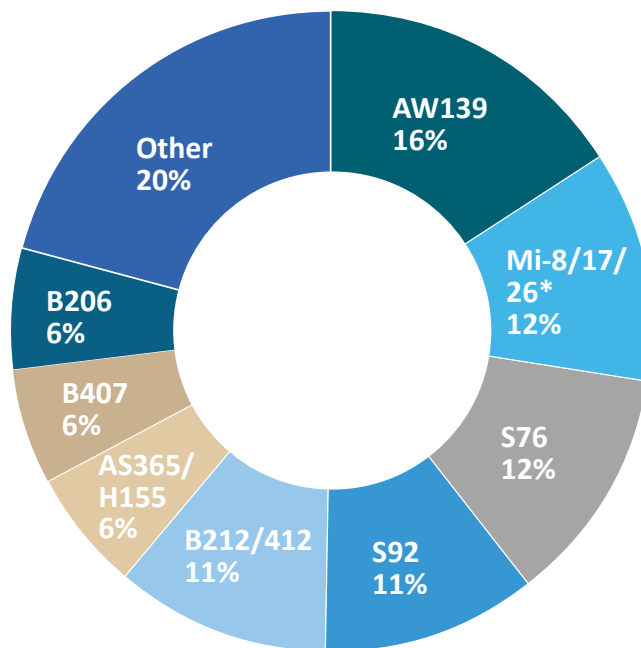
Figure 3.1 – Estimated Global Oil and Gas Fleet Numbers by Type

Figure 3.1 shows the proportion of the OEM-reported global oil and gas fleet by aircraft type. Table 3.1 below shows the same data in more detail.

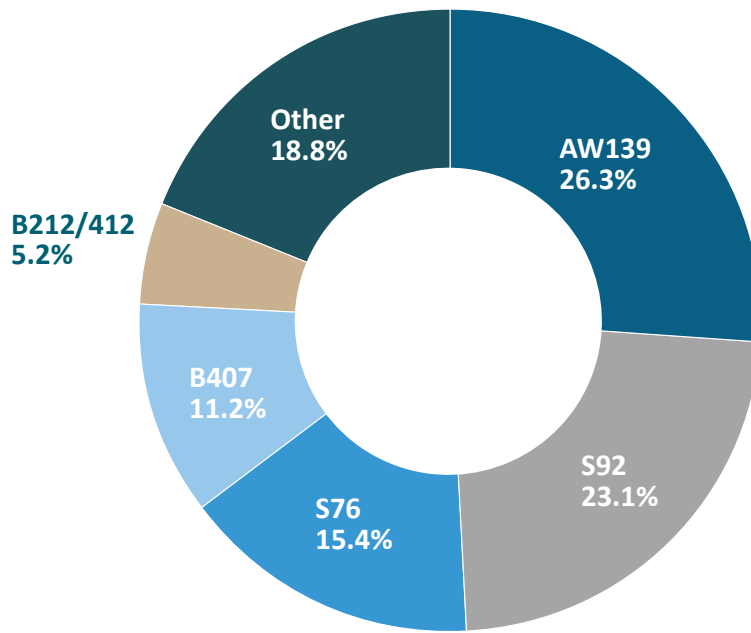
Figure 3.2 – Breakdown of Members’ Reported Fleet by Type

Figure 3.2 shows the breakdown of aircraft types for the members’ reported fleet shown in Table 3.1. In the ‘Other’ category, all individual percentages were less than 3%.

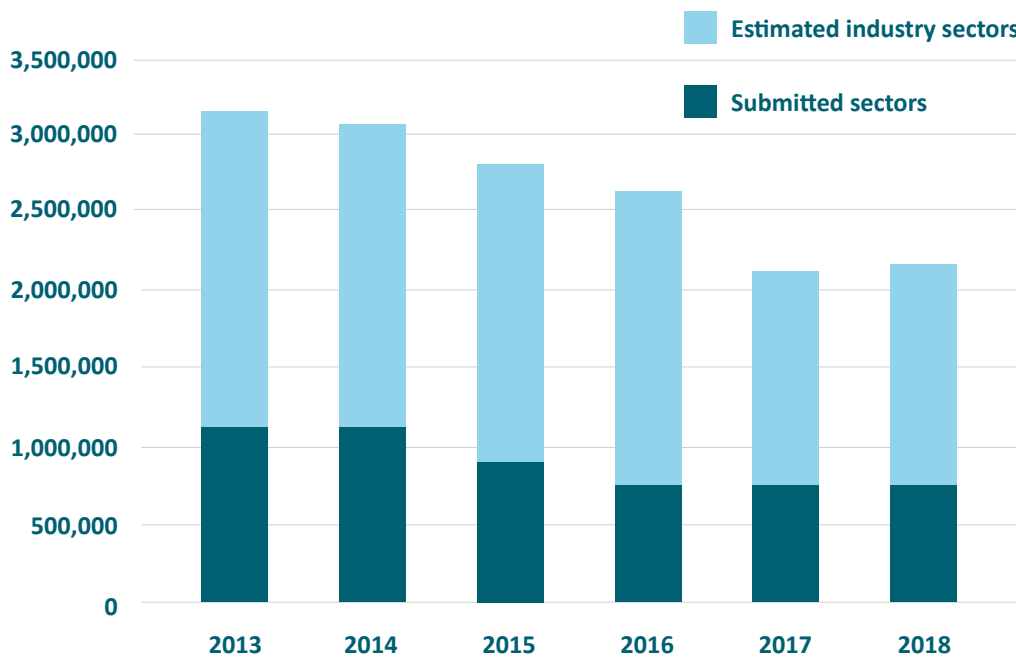
Figure 3.5 – Annual Sectors Flown

Figure 3.5 shows the sectors submitted by members and the estimated industry sectors, derived from OEM industry hours for the last six years. The submitted sectors match the trend of the submitted flight hours, which is perhaps to be expected; the reduction in flying hours has been a reduction in volume of flying, not a large change in the type of flying being done. The industry sectors have been calculated using the industry hours supplied by the airframe manufacturers and mean sector times for the different aircraft types.

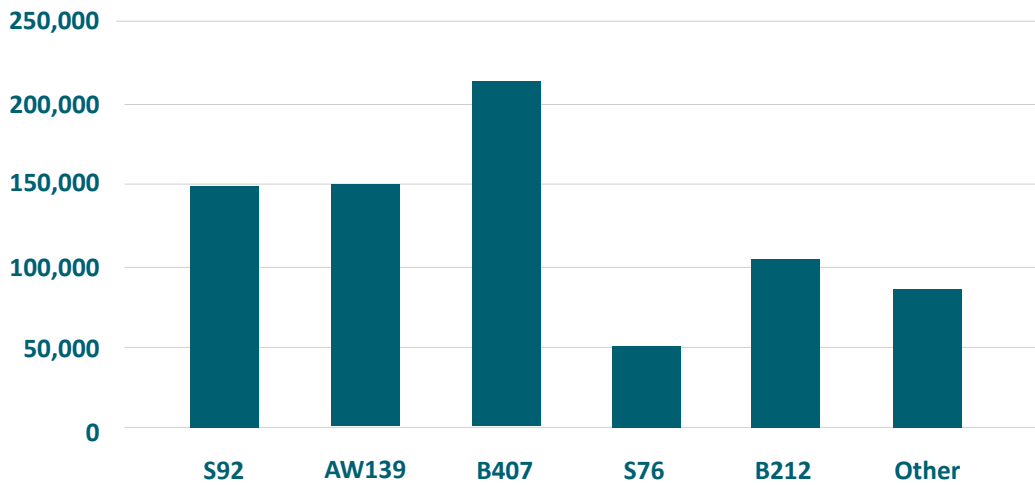
Figure 3.8 – 2018 Submitted Sectors by Aircraft Type

Figure 3.8 shows the breakdown of submitted 2018 sectors by aircraft type in the same order as presented for flight hours above.

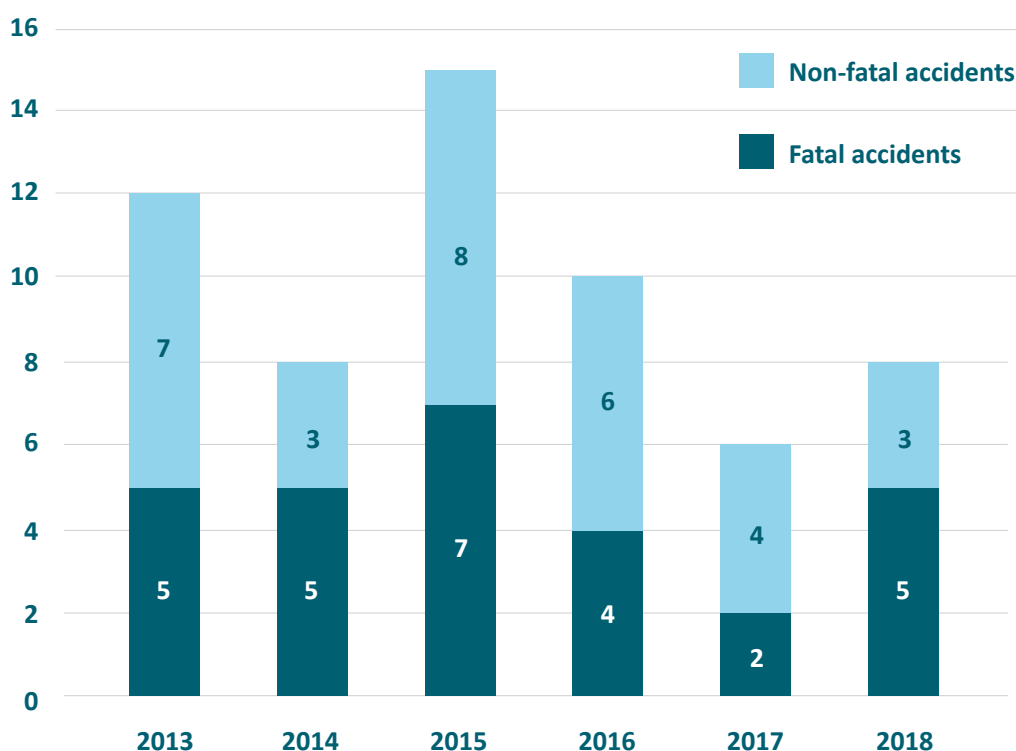
Figure 4.1 – Accidents by Year (fatal and non-fatal)

Figure 4.1 shows the distribution of fatal and non-fatal accidents over the period. Of the 59 accidents identified, 28 were fatal and 31 were non-fatal.

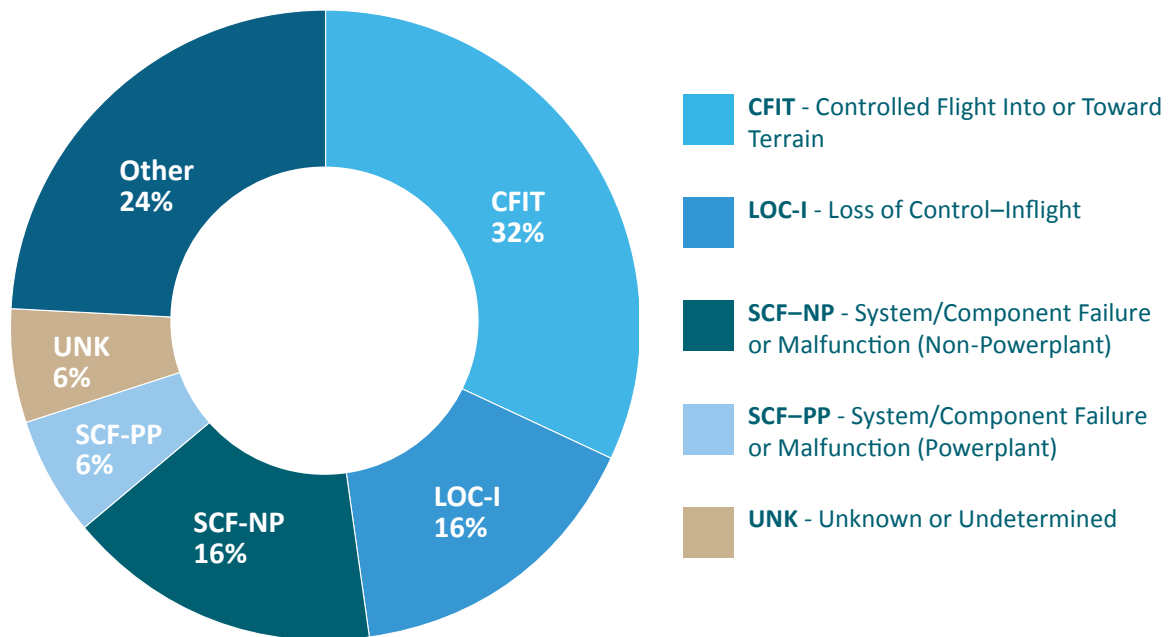
Figure 4.4 – CICTT Occurrence Categories for Fatal Accidents Only

Changing focus to only fatal accidents changes this breakdown significantly; Figure 4.4 shows the proportion of occurrence categories associated with fatal accidents only.

Figure 4.4 shows that controlled flight into terrain or water is the most common category associated with fatal accidents (CFIT = 32%) followed by loss of control in-flight (LOC-I = 16%) and non-powerplant system or component failures (SCF-NP = 16%). Here ‘Other’ contains 7 categories each with a proportion of 4% or less.

The three most common occurrence categories for fatal accidents were: controlled flight into terrain or water (CFIT); loss of control in flight (LOC-I); and system or component failure or malfunction – non-powerplant (SCF-NP). These 3 occurrence categories accounted for two-thirds of the fatal accident occurrences.
